DAMAGE ASSESSMENT TO PLAQUEMINES PARISH FEDERAL LEVEES.

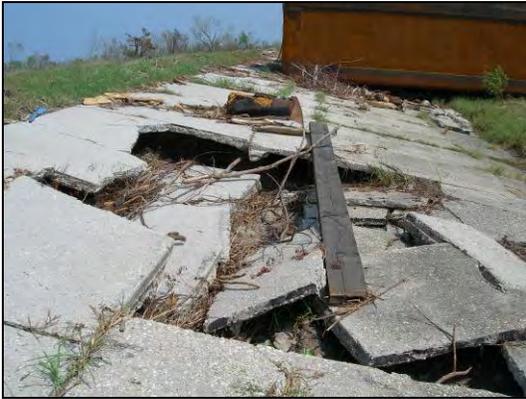
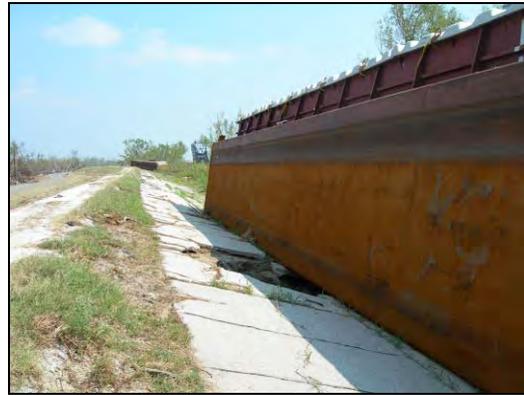
This reach of levee is part of the Mississippi River Tributaries (MRT) project and is not part of the New Orleans to Venice Hurricane Protection Project. This information is included here for completeness. The bulk of the damage in this reach is riverside paving block damage caused by debris or by barge impact. Approximately 300-feet of paving block is damaged and needs repairs or replacement. Figures 1 and 2 show typical paving block damage. There is also a minor amount of scour at the crown and top of the landside slope. Photos 3 and 4 are typical of this scour.

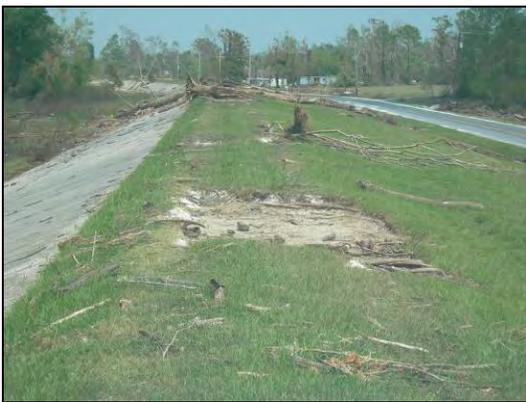
Figure 3

The bulk of the damage in this reach is riverside paving block damage and minor crown erosion. Approximately 3.4-miles of paving block and 5.9-miles of the crown needs repairs or replacement. Figures 3 and 4 show the minor crown erosion.

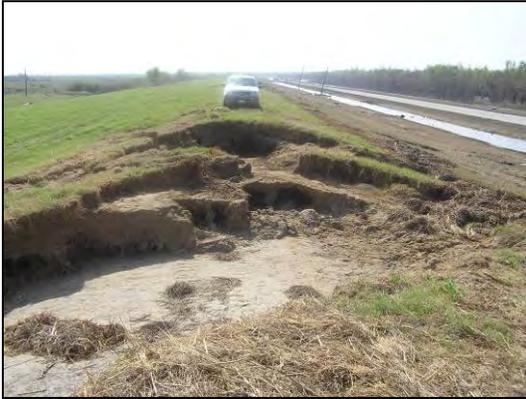
Figure 5

Damage to this levee consists of erosion damage to the levee crown and various, small reaches of the landside slope. Photos 5 and 6 portrays the heaviest erosion damage to the earthen levee. Approximately 2.6 miles of crown erosion and less than 500-feet of riverside and landside slope erosion is identified.

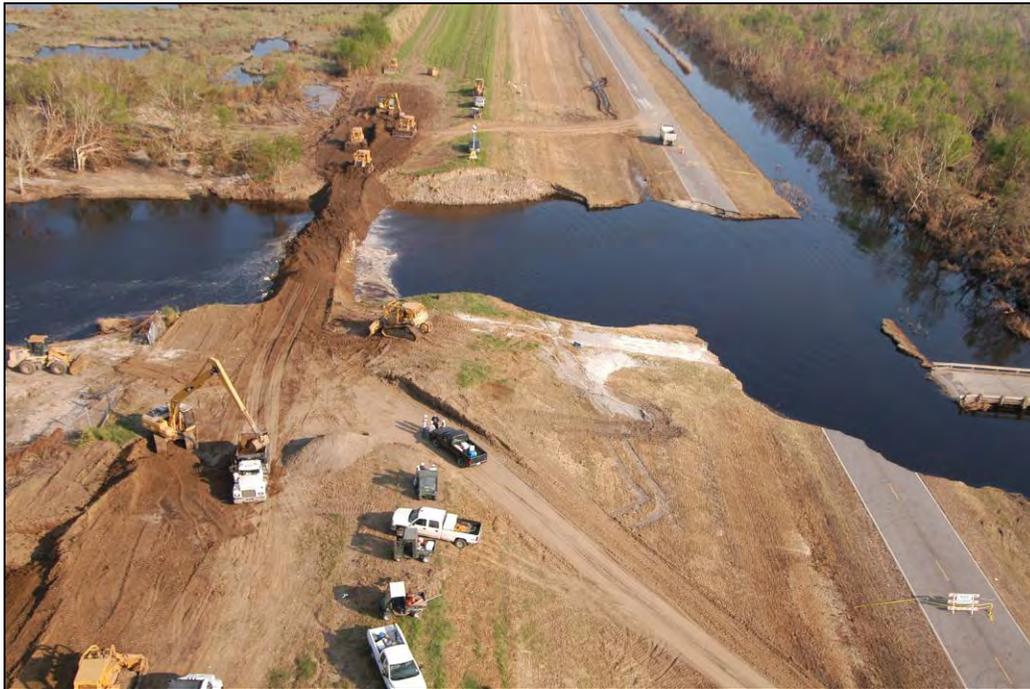
The back levee sustained a complete breach with associated scour hole between the La Heche and Bellevue pumping stations. A ground survey conducted after the hurricane shows that the breach is 190-foot wide at the levee centerline and the scour hole extends to -21 NGVD. Figure 7 (taken on/about 15 September 2005) shows this breach with an intermediate level of protection established across it.

These estimates assume that sand will be placed into the deep scour holes up to elevation zero. Above elevation zero, all construction will be completed with compacted clay. The estimates of breach repair also include volumes for riverside rock cofferdams and 60-foot deep sheetpile cutoff walls.

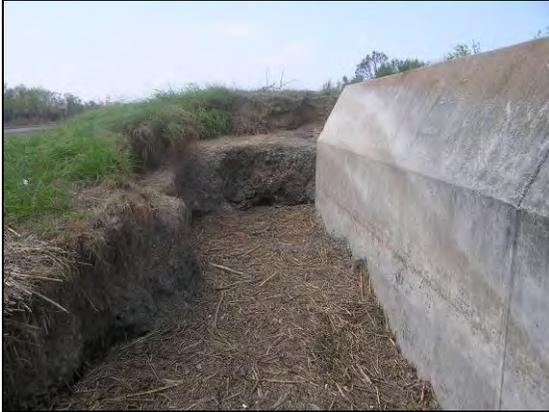
Figure 8

Two pumping stations in the district evacuate storm water to the Gulf. These are known as the Bellevue Pumping Station and the Point A La-Hache Pumping Station. Erosion damage occurred to both ends of the external I-wall where the levee ties into the pump station superstructure. Figures 8 and 9 illustrate this erosion.

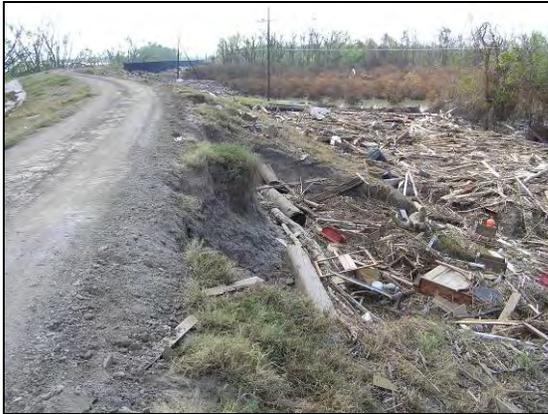
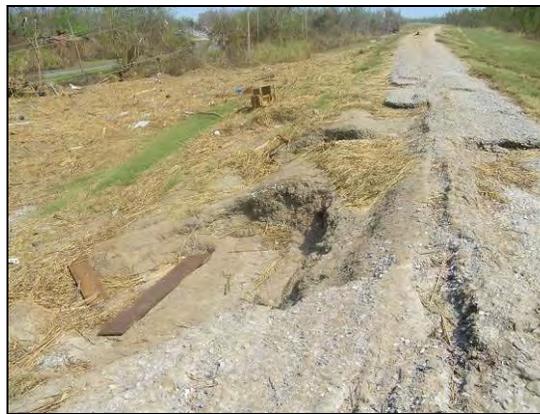
This reach of levee is part of the Mississippi River Tributaries (MRT) project and is not part of the New Orleans to Venice Hurricane Protection Project. This information is included here for completeness. Damage is confined to river miles 62 to 47.5 and consists of 0.8-miles of riverside paving block damage, 2.4-miles of minor crown erosion, 5.4-miles of minor landside slope erosion, and 0.4-miles of major and extreme landside slope erosion. Paving block damage is similar to that previously described. There are no breaches or flood walls identified in this reach. Figures 10 and 11 show typical minor crown and landside slope erosion damage. Figure 12 shows the extreme landside damage near Point Celeste.

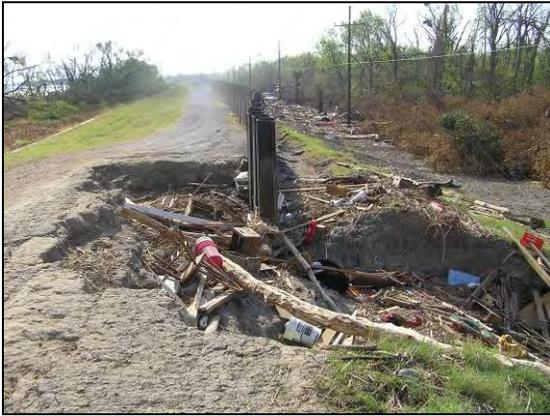
Figure 13

(2.8-miles). The typical erosion damage at the ends of sheetpile and concrete capped hurricane protection walls is shown in Figures 13 and 14.

Notice the soil erosion evident behind each of these walls. This erosion continues for the entire length of wall indicating a significant overtopping. A closer view of this typical erosion is shown in Figure 15.

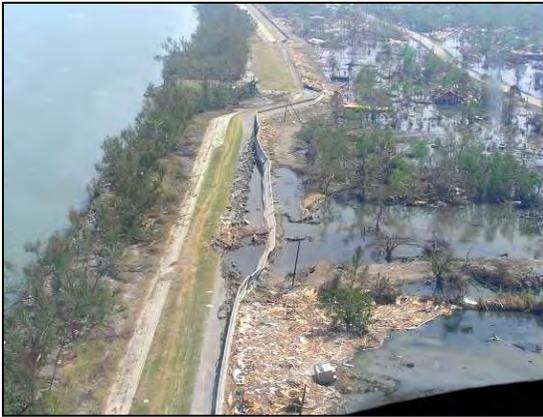
Figure 16

This reach of levee experienced little or no paving block damage, nor crown or riverside slope erosion. There is 5.3-miles of landside slope erosion and 2-miles of damaged sheetpile and concrete capped floodwall as well as attendant erosion behind the walls due to overtopping. Figures 16 and 17 illustrate these failures. Although all walls did not fail as dramatically as shown in figure 16, they do manifest some level of distress.

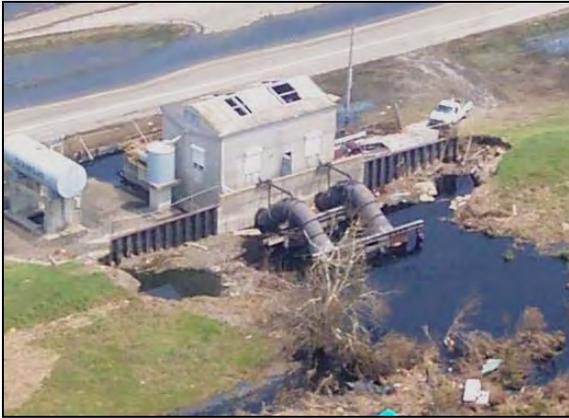
The observed damage is the signature erosion at the ends of the concrete transition wall at the Diamond pump station. Figure 18 shows the Diamond pump station and figure 19 shows a closer view of the erosion. This erosion is similar to the erosion at other walls (see figures 9, 13, and 14). A detailed inspection of the pump station must still be completed.

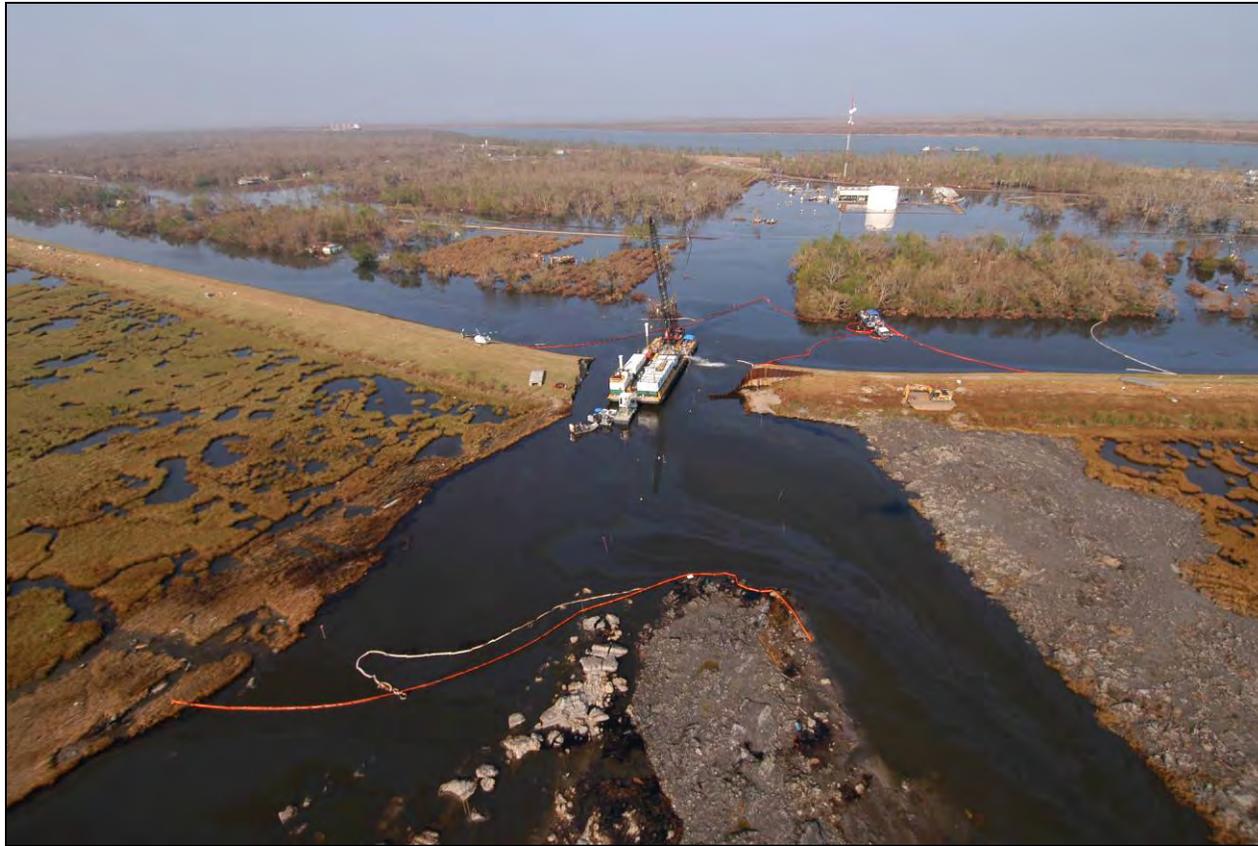
The back levee sustained minor damage to 0.9 miles of crown, major damage to 0.6 miles of marsh side slope, and levee breaches including: near the Hayes Pump station, marsh side erosion downstream of the Hayes pump station, the breach near Nairn (Shell Oil), and downstream of Nairn. Some of these breaches were confined to the embankment and others created substantial scour holes. Figure 20 shows the breach at Nairn (Shell Oil). A measured profile along the levee centerline shows that the scour hole is 125-feet wide. An incomplete scour hole profile shows that it is a least 14-feet deep below the prevailing ground surface.

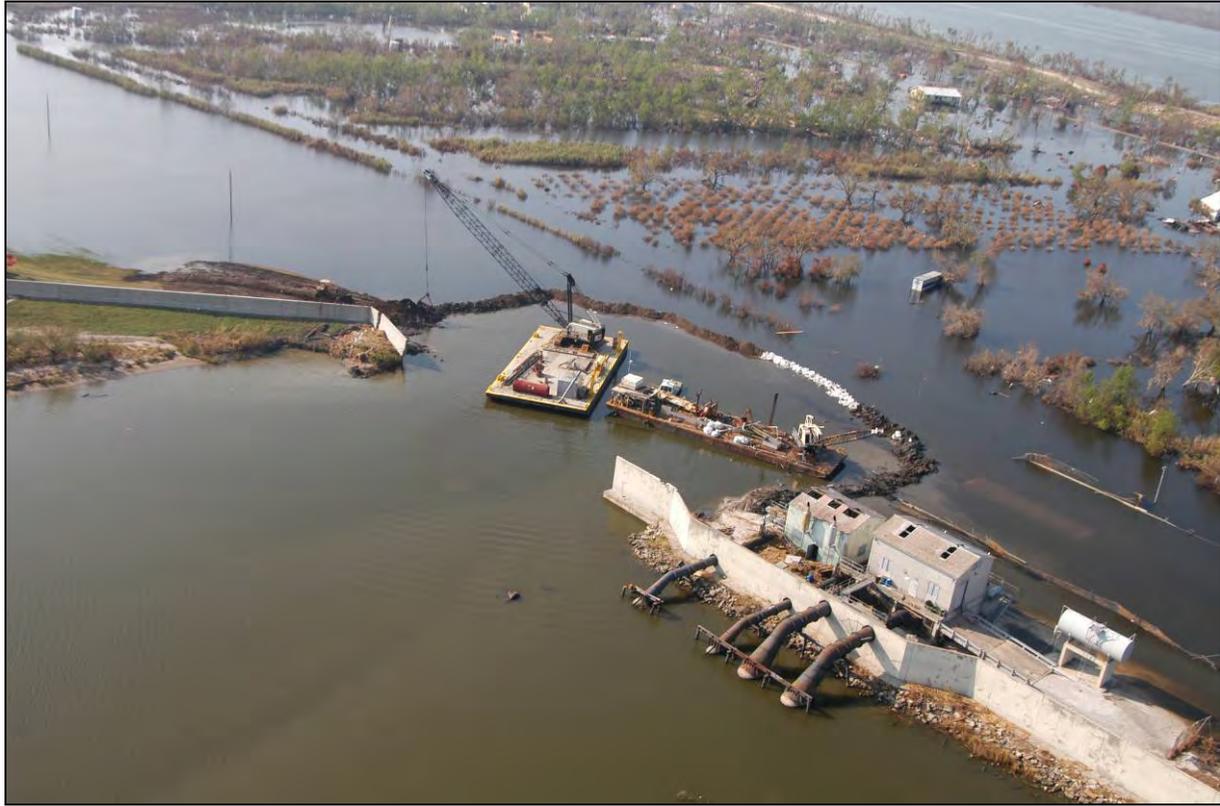
Figure 21

The breach at the Sunrise Pumping Station (Figure 21) is located in this back levee. This breach destroyed about 200-feet of structural T-Wall. The ground survey at this breach shows that it is 180-feet wide along the levee centerline, 500-feet long from riverside to landside, and a 25 to 30-foot deep scour hole. The back levee also sustained ruinous damage to sheetpile walls in the vicinity of the Empire lock and canal, and to the levee crown on either side of the sheetpile. Figures 22 and 23 show the failed sheet piling in the back levee near the Empire Lock. In the remaining levee reach downstream of the Sunrise Breach, the back levee showed no visible damage. At the time of this writing, the Empire flood gate was still stuck in the open position
